Manhole Inspection Summary

Manhole # S25CC1028MH

Location Address: **1404 37TH ST**

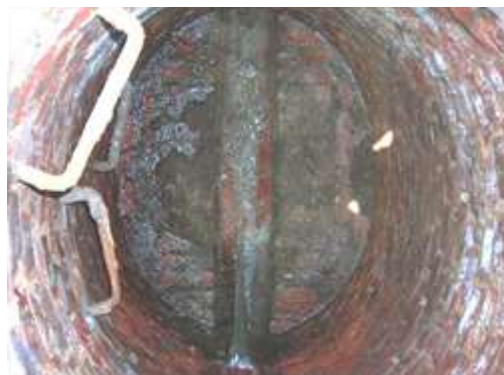
Top View

Adjustment, Corbel and Barrel infiltration.
Corroded steps. Bench debris.

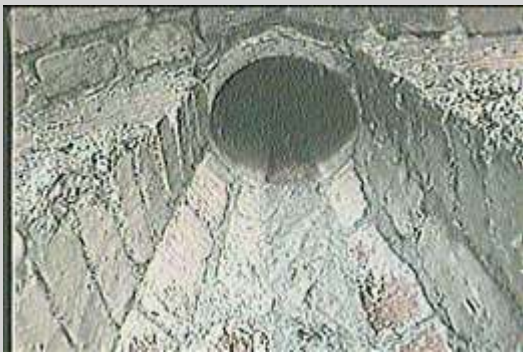
8 in. Circular Gravity Sewer Pipe Out @ 12 O'Clock

Barrel deterioration and infiltration. Bench and Channel deterioration.

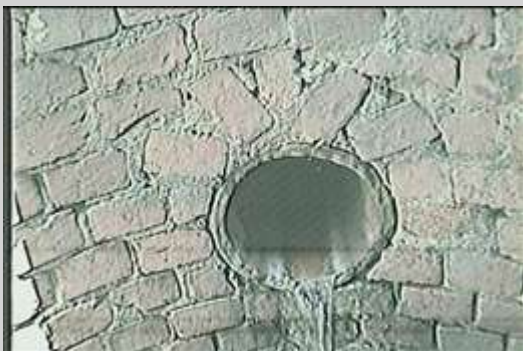
8 in. Circular Gravity Sewer Pipe In @ 6 O'Clock

Barrel deterioration and infiltration.

Infiltration: **Evidence** Pipe Seal Cond: **Cracked**

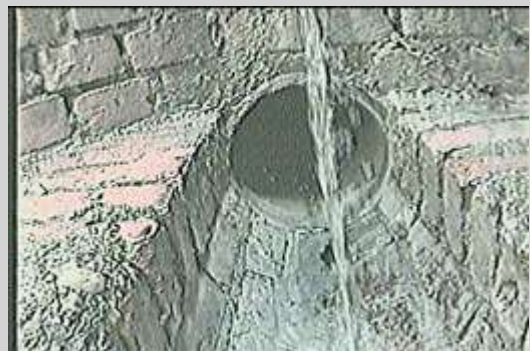
Drop In @ 6 O'Clock

Barrel deterioration and infiltration. Bench and Channel deterioration.

Drop Condition: **Clogged**
